TECHNICAL NOTE 4030

EXPERIMENTAL INVESTIGATION OF CERMET TURBINE BLADES  
IN AN AXIAL-FLOW TURBOJET ENGINE

By William C. Morgan and George C. Deutsch

October 1957

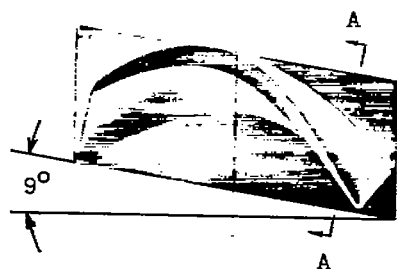
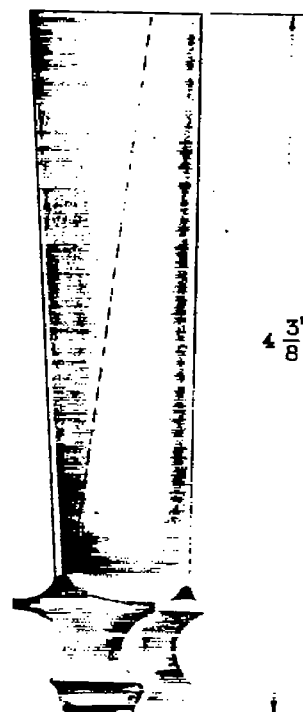
Figure 1. - Cermet turbine blade.

The root of the cermet blade (fig. 1) was skewed  $9^\circ$  relative to the turbine axis, as compared with  $2\frac{10}{2}$  used in the standard blades for this turbine. This change was made to reduce bending stresses in the root (ref. 5). The airfoil length was 0.030 inch shorter than standard for most of the tests (3 to 16, inclusive). This was done to eliminate possible rubbing between blade tips and turbine shroud, in the event of shroud deformation.

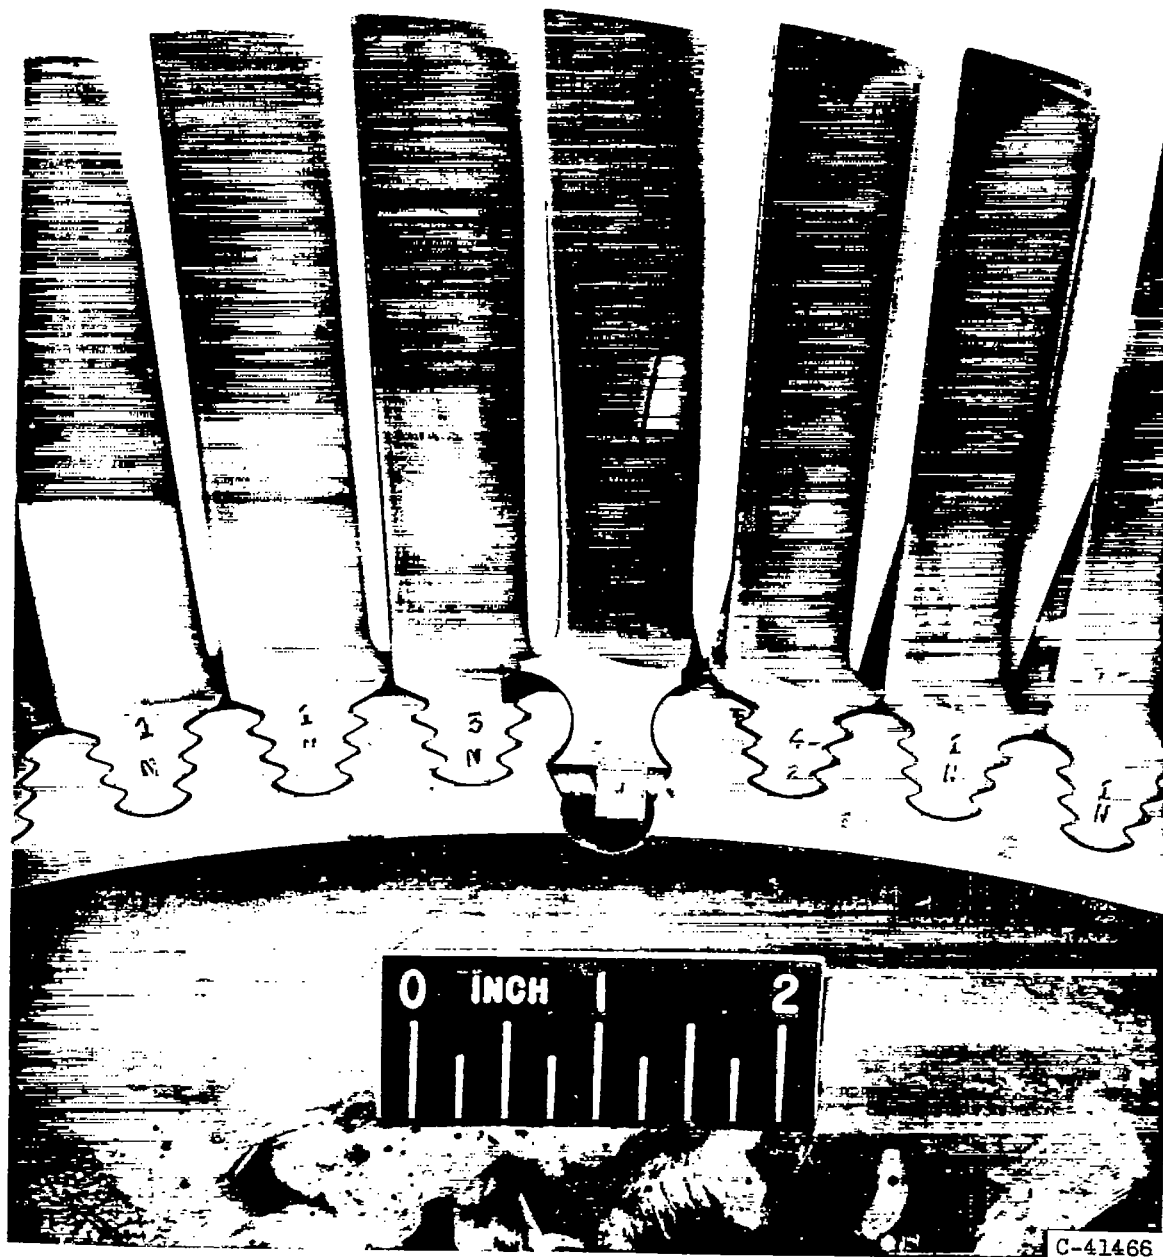
Figure 3. - Cermet turbine blade installed in standard spacing.

A third rotor used in this program was modified to provide for only two cermet test blades mounted diametrically opposite. The test blades were installed with the same spacing as the metal blades, as shown in figure 3. The purpose of this modification was to duplicate more closely the airflow conditions in a wheel with a full complement of cermet blades. An unfavorable rim-stress condition was introduced by the skewed root serration adjacent to the standard serration. However, additional cooling air was supplied to the rim, and the rim temperature was lowered to a safe level.

- (a) Elimination of excessive space between cermet and adjacent standard blade; installation in tests 15 and 16 of a single cermet blade in same relative position as standard metal blades, as shown in figure 3
- (b) Use of phased nozzle assembly to damp out excitation from the 64<sup>th</sup> order of turbine speed
- (c) Use of 57-vane nozzle assembly to bring excitation forces below the resonant frequency of a majority of blade complex vibration modes

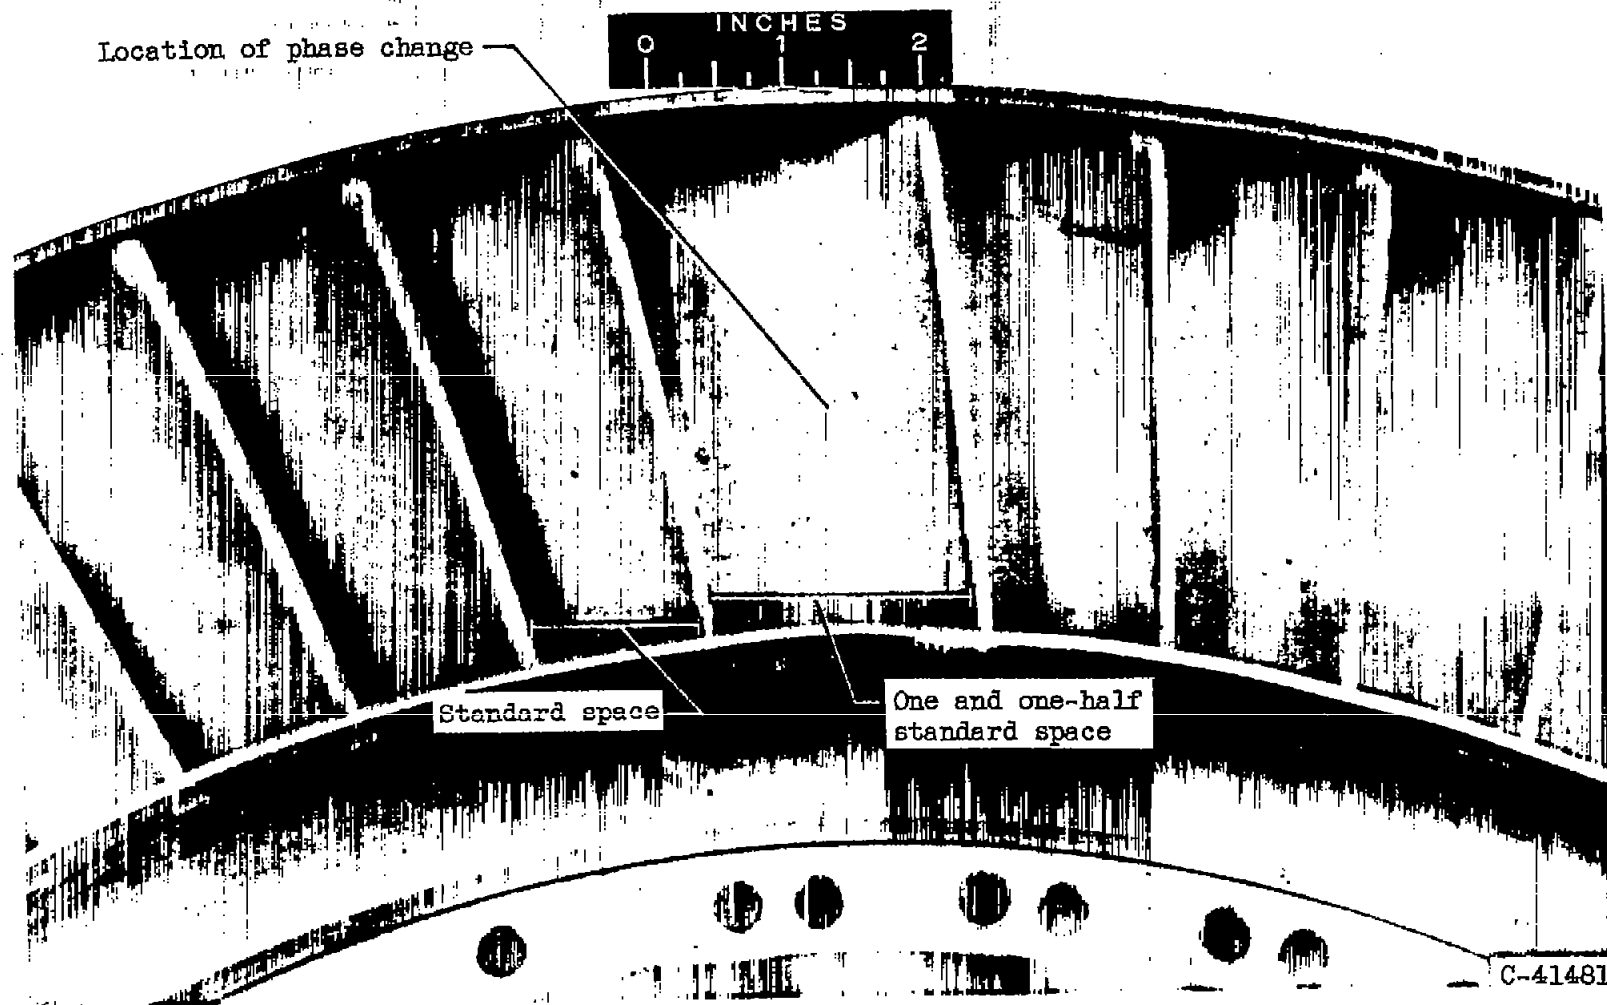
Figure 4. - Phased nozzle diaphragm, showing location of phase change; 61 standard spaces; 2 phase-change spaces.

One special assembly had 57 vanes equally spaced (tests 8, 8a, and 8b). In the fabrication of the second modified assembly ("phased" assembly for tests 10, 11, and 12) a standard unit was cut apart on a diameter. An arc segment containing one vane adjacent to a cut face was removed, and the remainder of that half of the assembly was revolved through an arc equal to one-half standard vane space. With the two parts fixed in this relation, material was added to the inner and outer rings where required to complete the reassembly. Figure 4 shows the resulting vane spacing at the location of phase change. There was a similar discontinuity nearly diametrically opposite.
